CHIEF DIRECTORATE OCCUPATIONAL HEALTH AND SAFETY

DIRECTORATE: ELECTRICAL AND
MECHANICAL ENGINEERING

- 3 incidents/cases investigated
 - Cable car
 - Gas explosion
 - Illegal connections

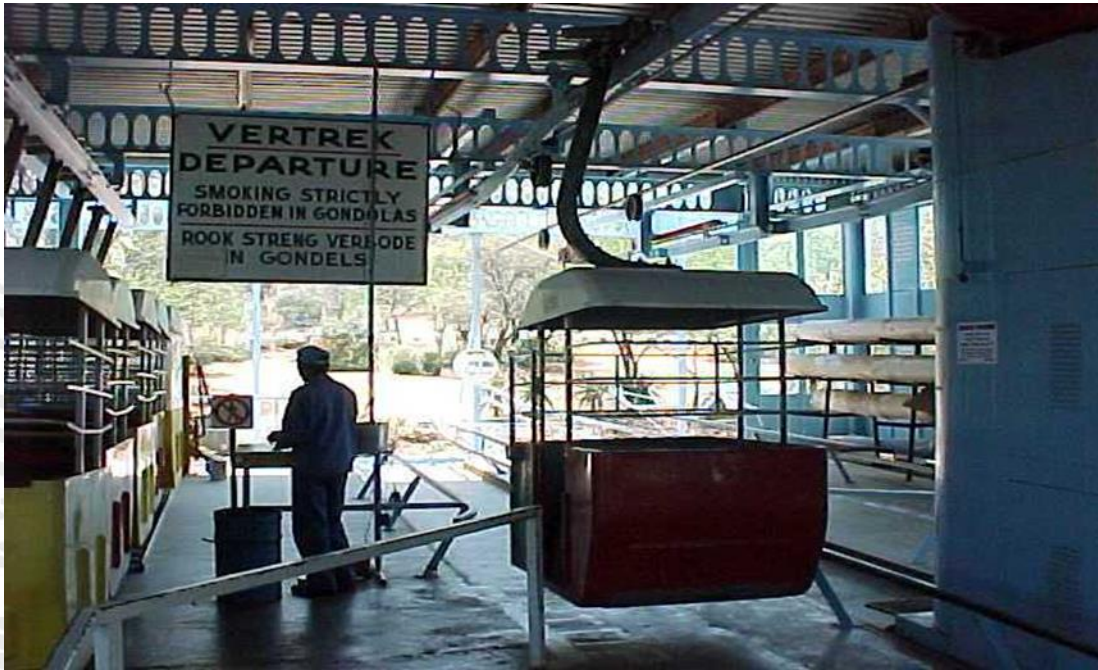
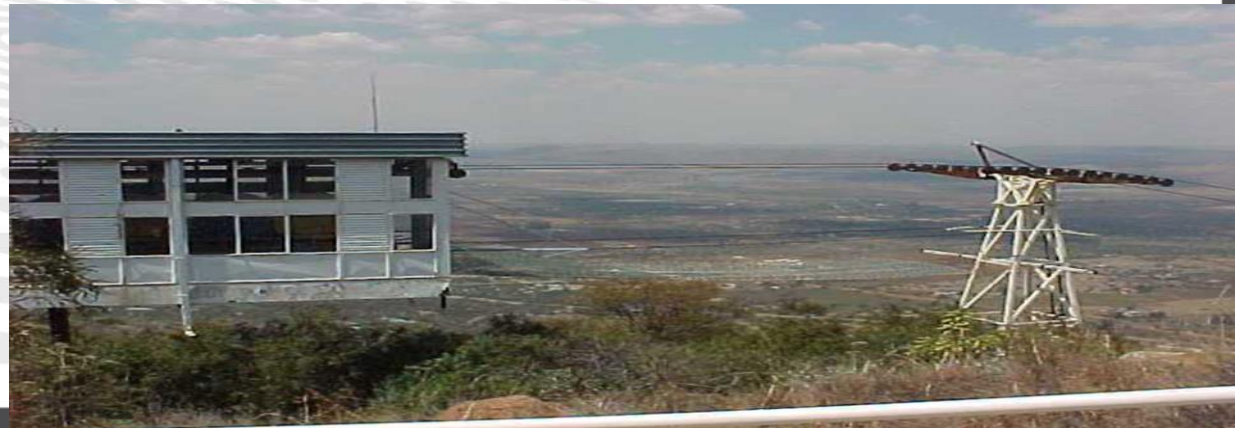
Cable car

- Two gondola carrying one person each travelled to the bottom station
- The third gondola was travelling to the top station
- As it approached the top station travelling-swung by strong wind and hit tower
- on its landing at top station it bumped the guide rails and the cable
- Wheels on the C clamp missed the rail
- The car fell down with side of the door on the floor
- The main cable also came off the two towers
- The plant stopped running

- Strong wind swung the gondola and resulted in the gondola landing unsafely at the top station.
- Air monitoring devices on the plant were not adequate
- Competence of the operator at top station was not appropriate
- The competent person on site could not perform proper monitoring

- Owner sold the business
- Transportation plant upgraded to Canadian standard
- New installation approved by DEL

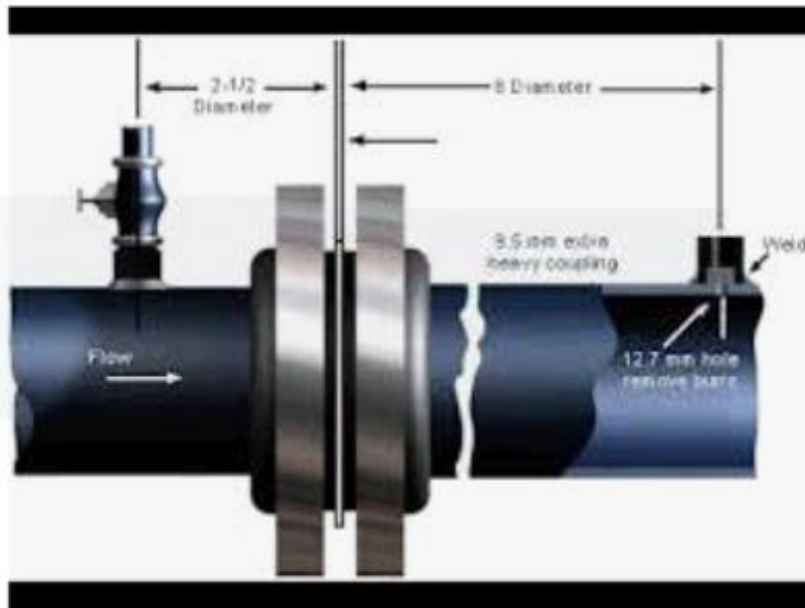
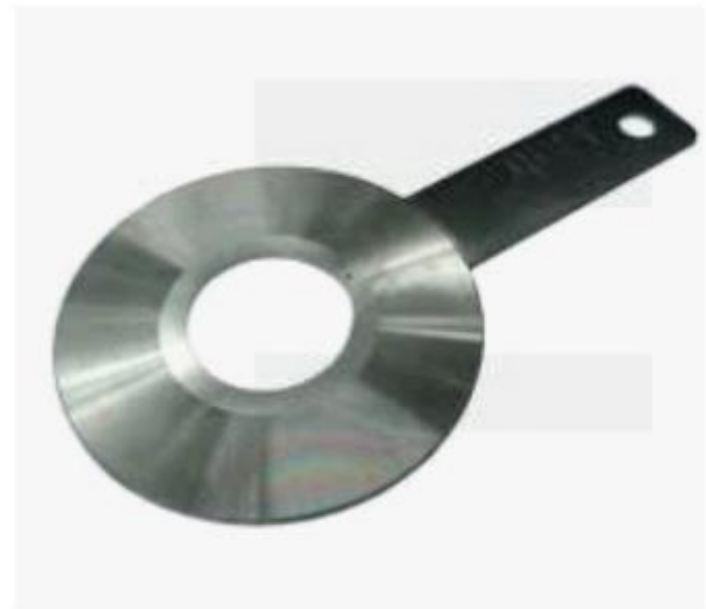
Orifice plate - Measuring of quantity of the medium that flow in the pipe line

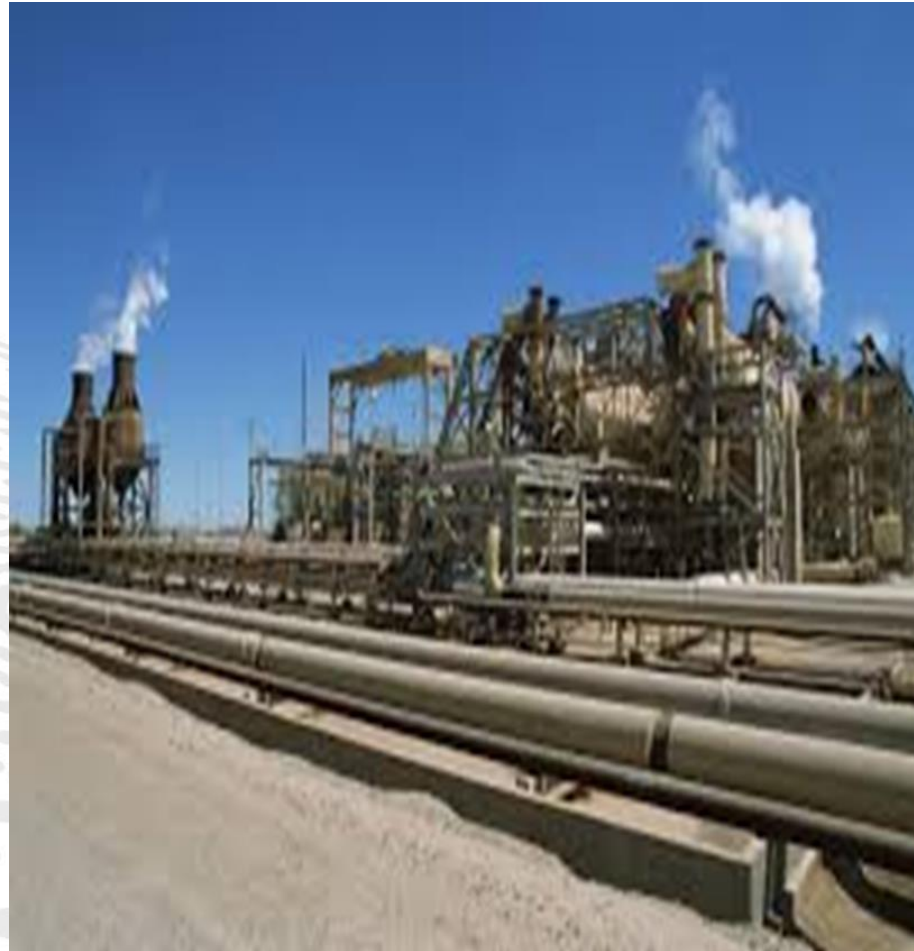
- A sub-contractor was instructed to replace a orifice plate on a main gas line during a shutdown.
- Whilst un-bolting the flange, the gas in the pipeline started to escape.
- This was followed by a huge explosion that resulted in 10 fatalities and 64 injured persons.

- The sub-contractor was allowed to replace the orifice plate without following proper procedures.
- No work permit was given to him, but has been given instruction to continue with the replacement of the orifice plate.
- Although this orifice plate was in the shutdown area, this pipe line could not be isolated for this shutdown. The pipeline was a T-off from the main pipeline without a valve. between the orifice plate and T-off.

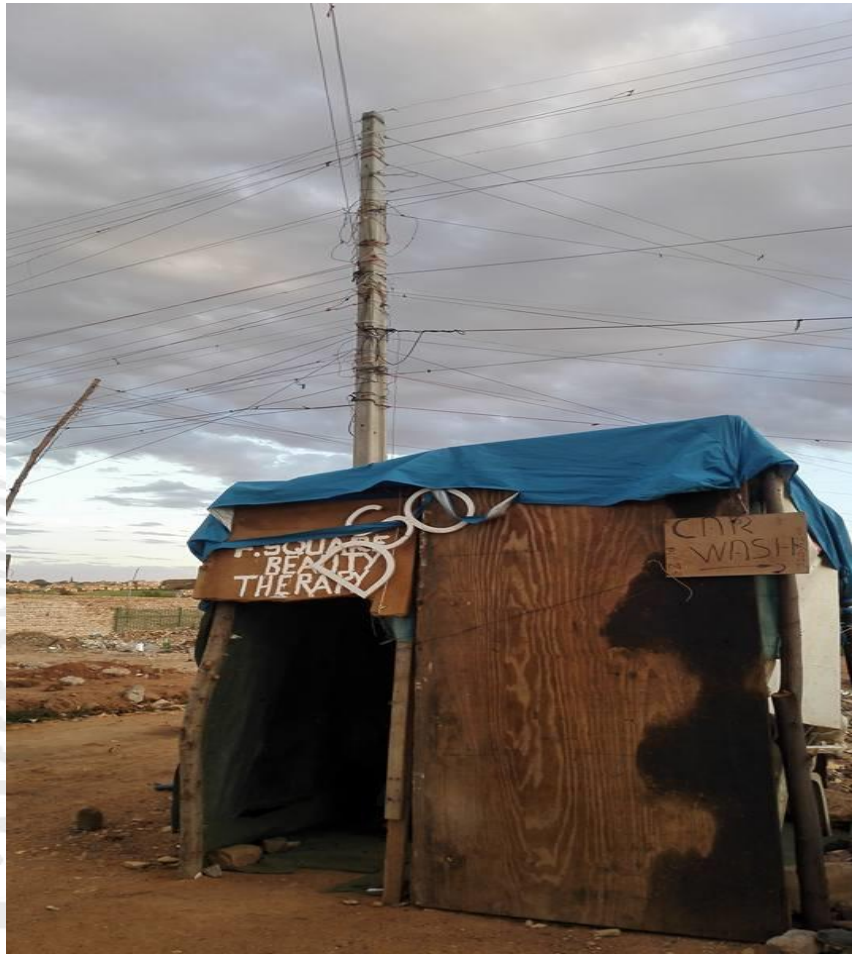
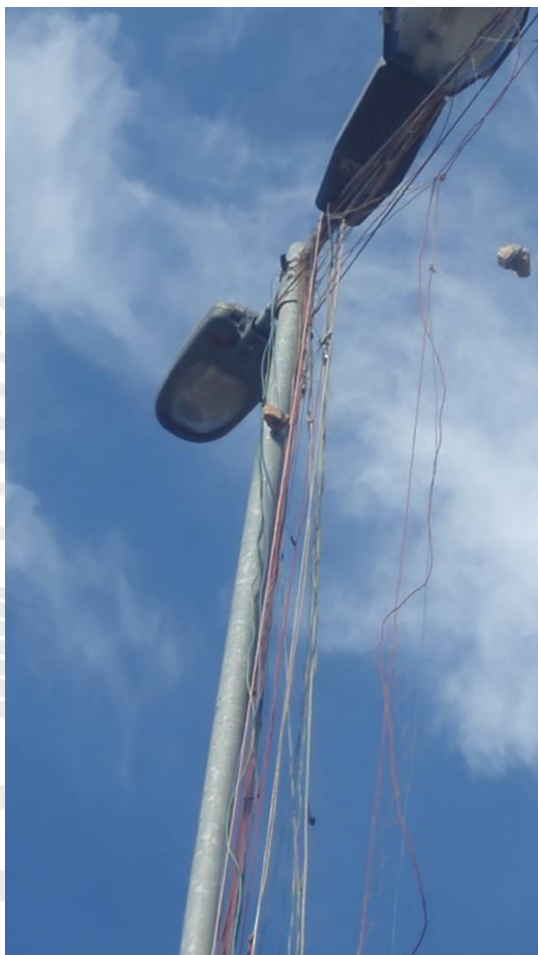
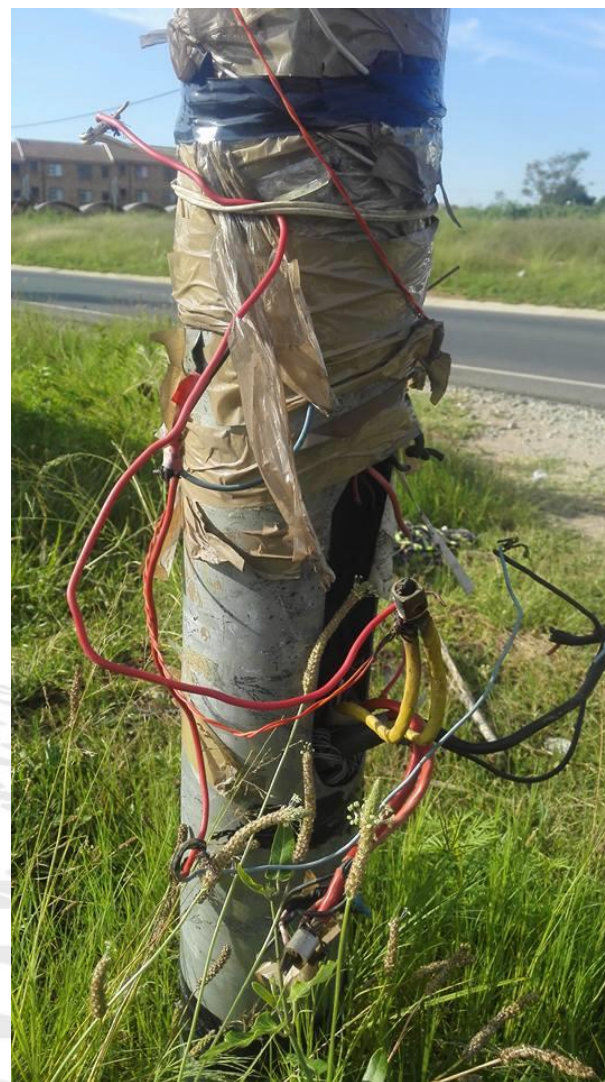
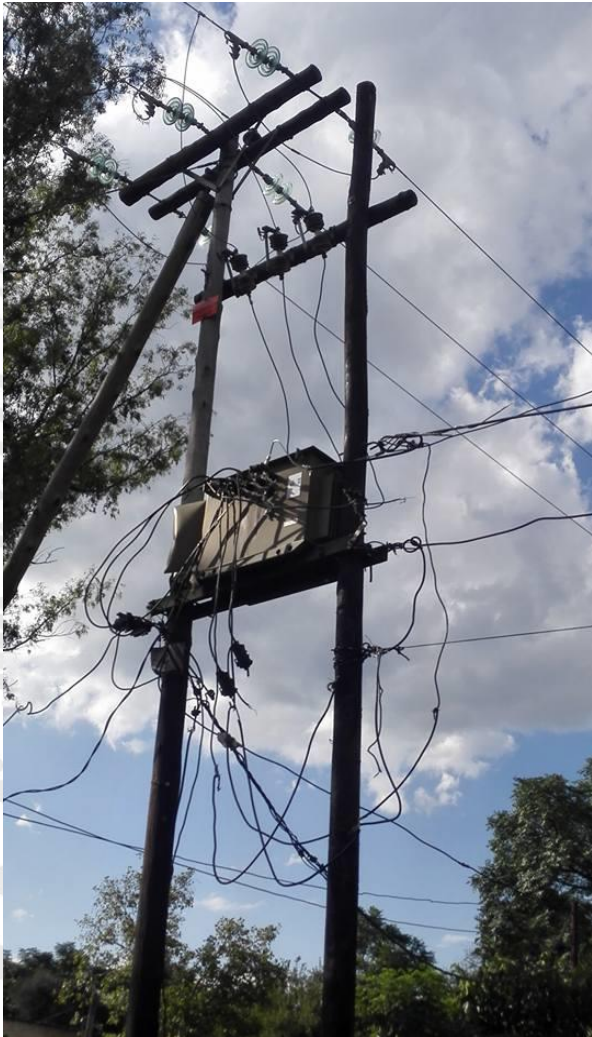
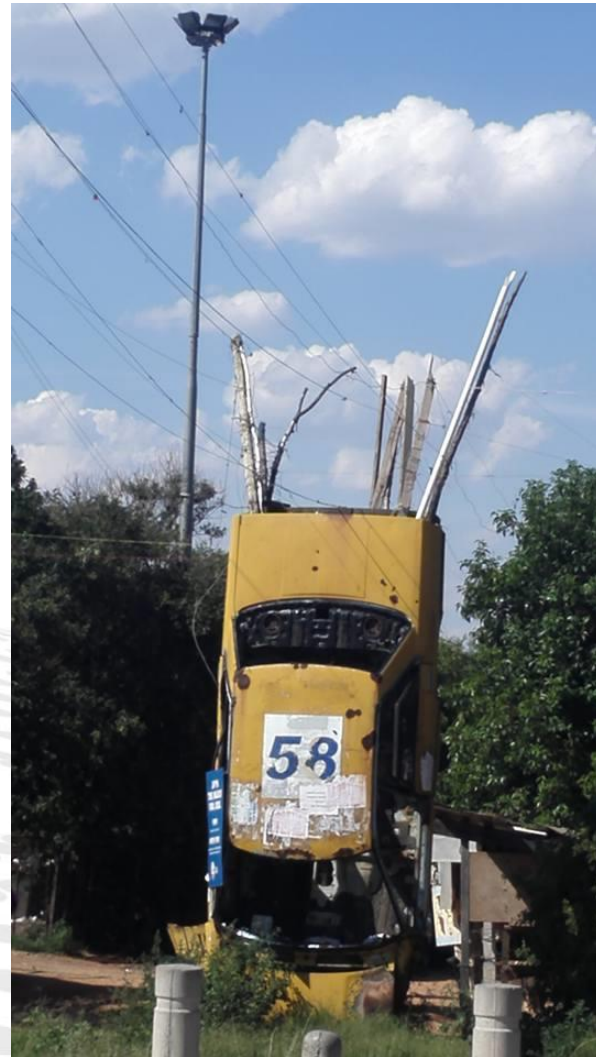
- Illegal connections and stealing of copper are a common occurrence.
- In most of the cases, the illegal connections are done in a unsafe manner that expose the public to dangerous situation.
- Where copper is stolen, the substations and miniature substation are left open with live exposed conductors.

- Copper theft has also cause many incidents where the culprits and innocent people have been electrocuted.
- In some cases, when the power lines are cut, it causes the remaining lines hanging low that expose people and animals to these live conductors.

- The Department will continue, through its Regional Electrical Safety Forums, to stop these illegal activities by working with the electrical suppliers and South African Police Services.
- These power failures also cause lost of working hours where offices and factories are without electricity.
